**Flood Control Project Maintenance
Levee Inspections
LMA District Cover Sheet
Spring 2013 Levee Inspection Results**

Reclamation District No. 0765 Glide

Spring 2013 Levee Inspection Results

Waterway		Bank	Unit Miles
Unit No. 01 Sacramento River		Right	1.74

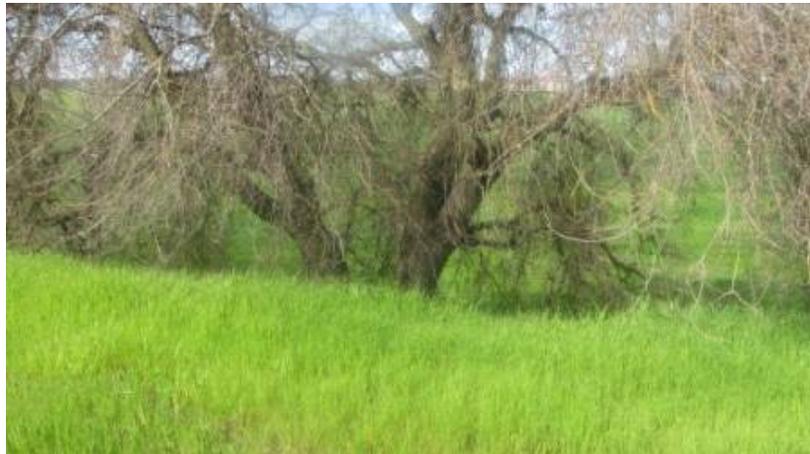
Levee Mile Report Line	8
Start Levee Mile	0.12
End Levee Mile	0.19
Location	Land Side
Category	
Item	Trim / Thin Trees
Looking west at trees on landside toe.	
richard_s_20130304_718.jpg

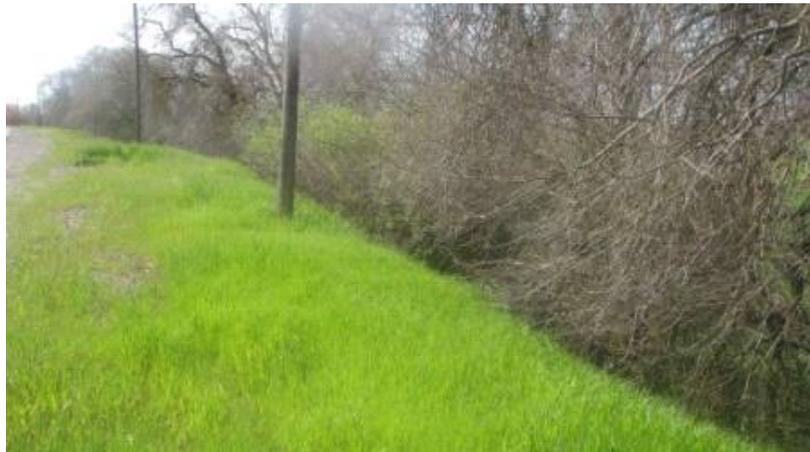
Levee Mile Report Line	8
Start Levee Mile	0.12
End Levee Mile	0.19
Location	Land Side
Category	
Item	Trim / Thin Trees
Looking downstream (south) at trees on landside slope & toe.	
richard_s_20130304_719.jpg

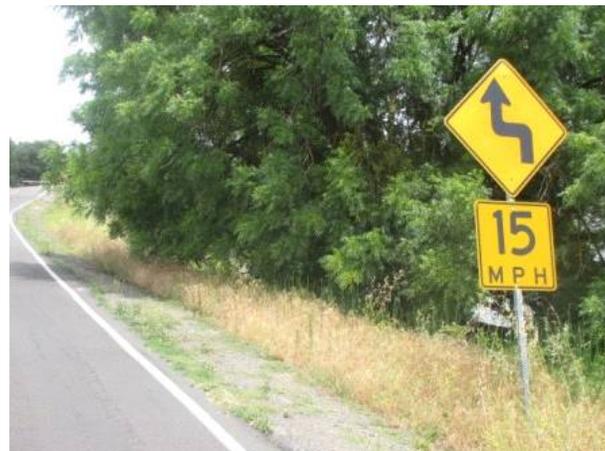
Levee Mile Report Line	15
Start Levee Mile	0.25
End Levee Mile	0.28
Location	Water Side
Category	
Item	Trim / Thin Trees
Looking northeast at overgrown trees on waterside slope.	
richard_s_20130304_708.jpg

LMR No.	Levee Mile		Category	Item	Location * + Rating	Action/Comment	GPS Latitude/Longitude		Issue No. Photo
	Start	End					Start	End	
15	0.25	0.28		Trim / Thin Trees	WS U Ma	T2 : Thin trees to allow visibility of the ground and room to flood fight.	38.499405 ° -121.560445 °	38.499042 ° -121.560430 °	11 Y
DWR ID: DWR_RD0765_01_s_2012_11									
16	0.31	0.31		Vegetation	LS M Ma	V2 : Remove the wild growth other than native grasses from the levee slopes. Inspector Comments: Wild berryvines on landside toe.	38.498516 ° -121.560463 °	38.498516 ° -121.560463 °	31 Y
DWR ID: DWR_RD0765_01_f_2012_31									
17	0.32	0.32		Trim / Thin Trees	WS M Ma	T2 : Thin trees to allow visibility of the ground and room to flood fight.	38.498453 ° -121.560360 °	38.498453 ° -121.560360 °	23 Y
DWR ID: DWR_RD0765_01_s_2012_23									
18	0.41	0.41		Trim / Thin Trees	LS M Ma	T1 : Trim trees to at least five feet above ground level.	38.497196 ° -121.560147 °	38.497196 ° -121.560147 °	21 Y

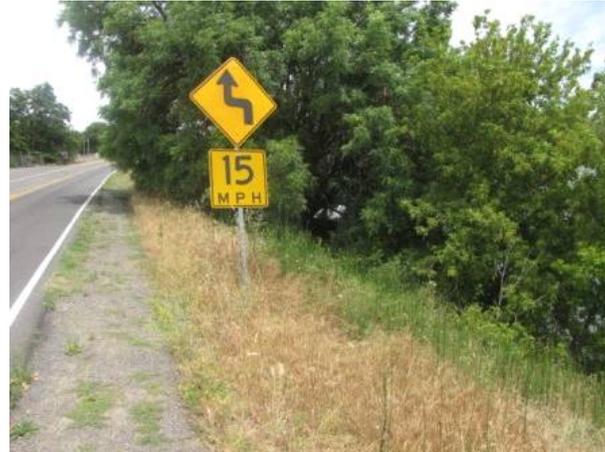
Levee Mile Report Line	15
Start Levee Mile	0.25
End Levee Mile	0.28
Location	Water Side
Category	
Item	Trim / Thin Trees
Looking north at dense trees on waterside slope from fall 2010 inspection.	
richard_s_20130304_709.jpg

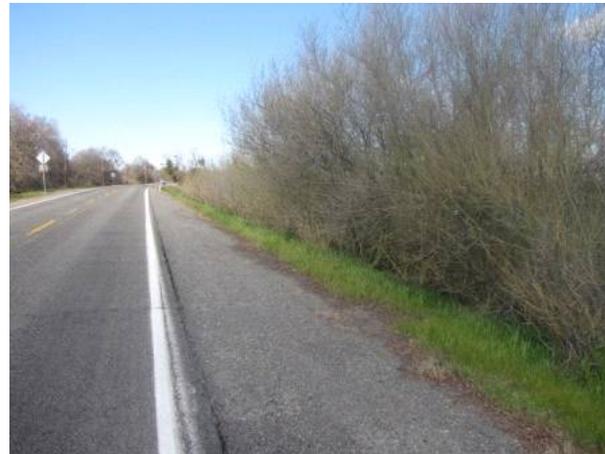
Levee Mile Report Line	15
Start Levee Mile	0.25
End Levee Mile	0.28
Location	Water Side
Category	
Item	Trim / Thin Trees
Looking upstream (north) at dense vegetation and trees from 2011 spring inspection.	
richard_s_20130304_710.jpg

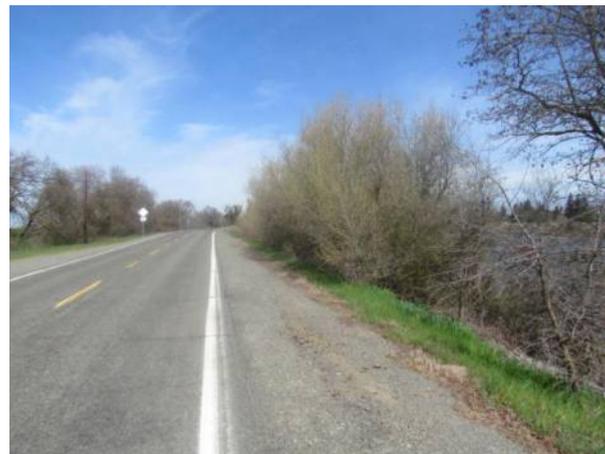
Levee Mile Report Line	15
Start Levee Mile	0.25
End Levee Mile	0.28
Location	Water Side
Category	
Item	Trim / Thin Trees
Looking north (upstream) at dense trees on landside slope and shoulder. (Spring 2013)	
richard_s_20130307_984.JPG

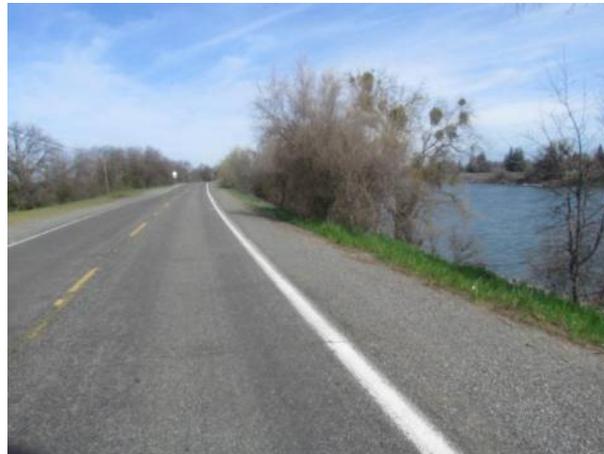
Levee Mile Report Line	17
Start Levee Mile	0.32
End Levee Mile	0.32
Location	Water Side
Category	
Item	Trim / Thin Trees
Looking north (upstream) at untrimmed trees on waterside shoulder and slope.	
richard_s_20130307_983.JPG

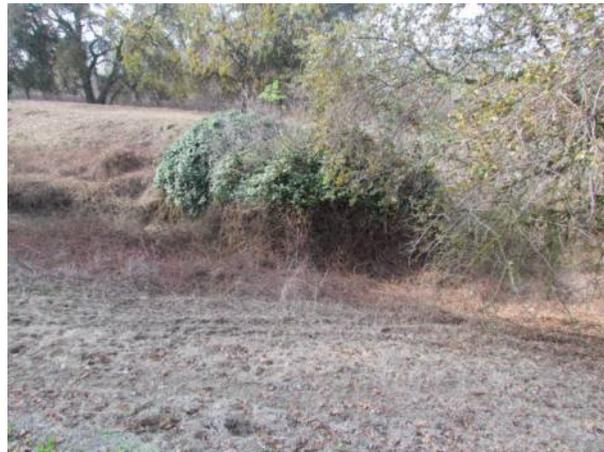
Levee Mile Report Line	20
Start Levee Mile	0.41
End Levee Mile	0.41
Location	Land Side
Category	
Item	Vegetation
Looking west at dense berryvines on landside toe.	
richard_s_20130304_736.JPG

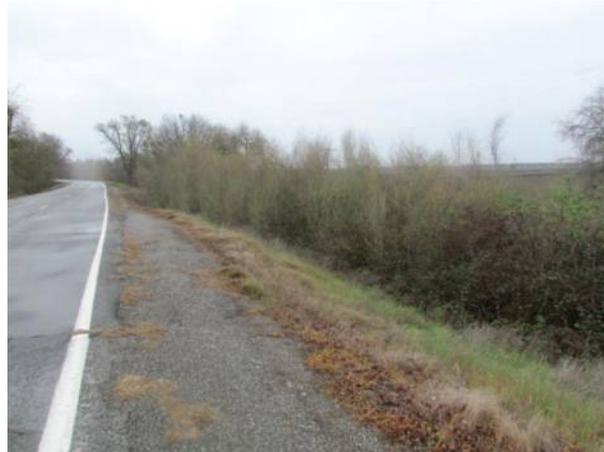
Levee Mile Report Line	21
Start Levee Mile	0.43
End Levee Mile	0.47
Location	Land Side
Category	
Item	Trim / Thin Trees
Looking southwest at dense vegetation on landside slope and toe.	
richard_s_20130304_725.jpg

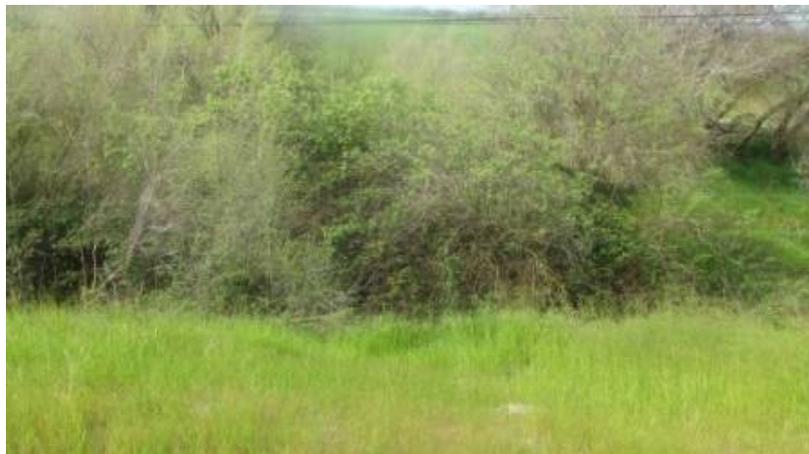
Levee Mile Report Line	22
Start Levee Mile	0.48
End Levee Mile	0.50
Location	Land Side
Category	
Item	Vegetation
Looking northwest at trees on landside toe from 2010 fall inspection.	
richard_s_20130304_726.jpg

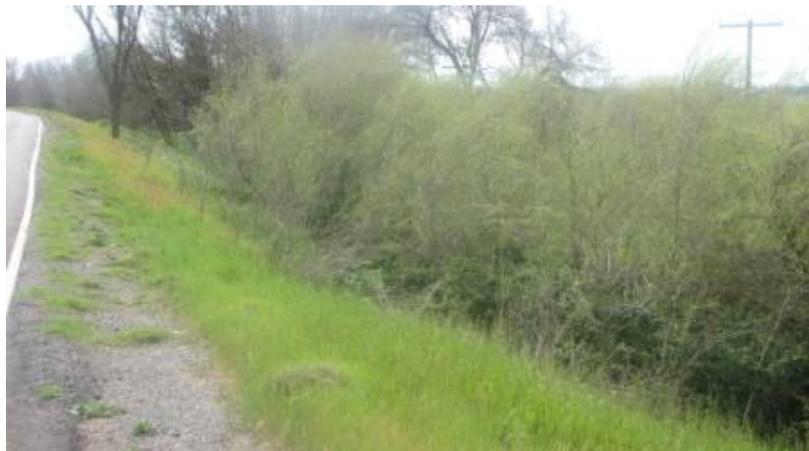
Levee Mile Report Line	22
Start Levee Mile	0.48
End Levee Mile	0.50
Location	Land Side
Category	
Item	Vegetation
Looking downstream (south) at trees on landside slope & toe.	
richard_s_20130304_727.jpg

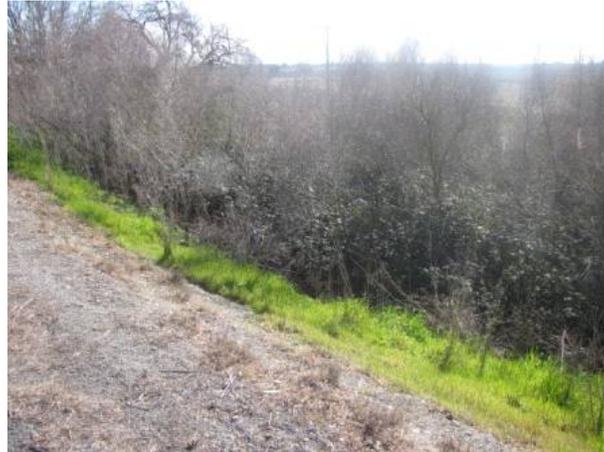
Levee Mile Report Line	22
Start Levee Mile	0.48
End Levee Mile	0.50
Location	Land Side
Category	
Item	Vegetation
Looking downstream (southwest) at dense vegetation on landside slope.	
richard_s_20130304_728.jpg

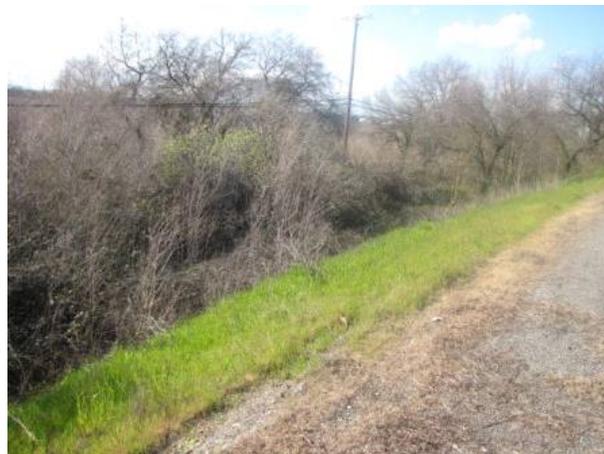
Levee Mile Report Line	22
Start Levee Mile	0.48
End Levee Mile	0.50
Location	Land Side
Category	
Item	Vegetation
Looking upstream (northwest) at dense vegetation on landside slope.	
richard_s_20130304_729.jpg

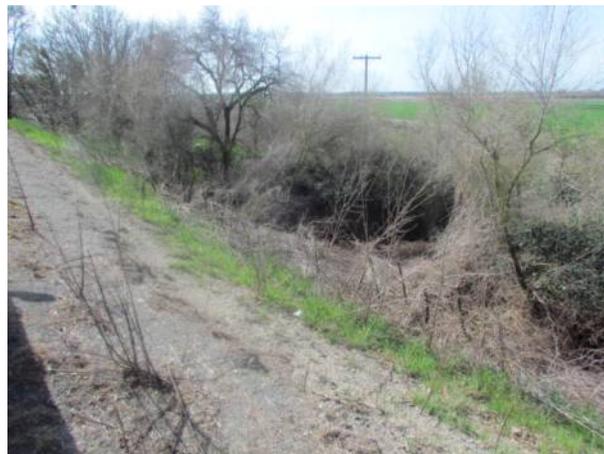
Levee Mile Report Line	22
Start Levee Mile	0.48
End Levee Mile	0.50
Location	Land Side
Category	
Item	Vegetation
Looking southwest at dense vegetation on landside slope and toe.	
richard_s_20130307_979.JPG

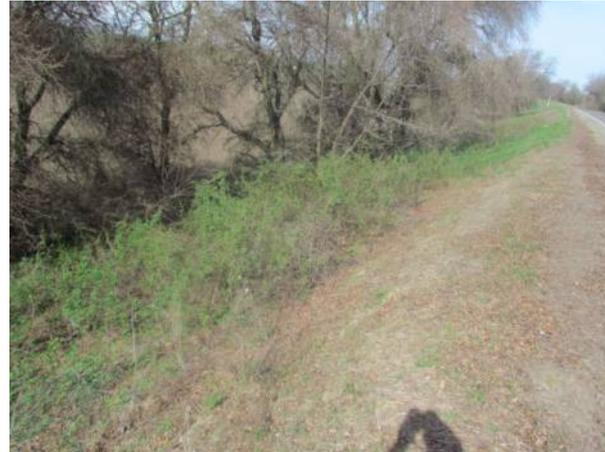
Levee Mile Report Line	27
Start Levee Mile	0.76
End Levee Mile	0.80
Location	Land Side
Category	
Item	Vegetation
Looking northwest at vegetation on landside slope.	
richard_s_20130307_980.JPG

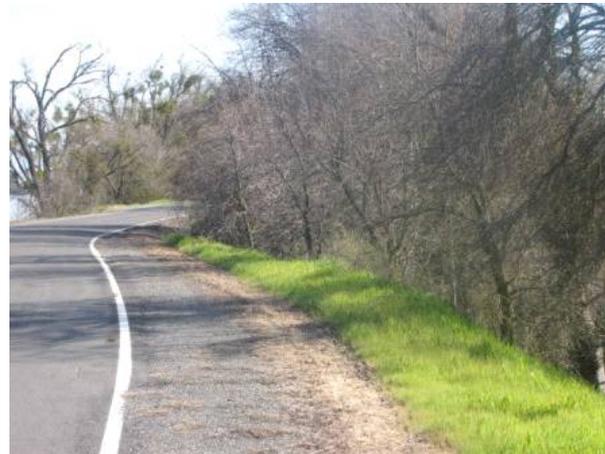
Levee Mile Report Line	29
Start Levee Mile	0.87
End Levee Mile	0.99
Location	Land Side
Category	
Item	Trim / Thin Trees
Looking downstream (south) at dense trees on landside slope and toe.	
richard_s_20130304_713.jpg

LMIR No.	Levee Mile		Category	Item	Location	Rating	Action/Comment	GPS Latitude/Longitude		Issue No. Photo
	Start	End						Start	End	
29	0.87	0.99		Trim / Thin Trees	LS	U Ma	T1 : Trim trees to at least five feet above ground level.	38.491283 ° -121.556360 °	38.489771 ° -121.555451 °	17 Y
DWR ID: DWR_RD0765_01_s_2012_17										
30	0.97	0.97		Vegetation	LS	U Ma	V2 : Remove the wild growth other than native grasses from the levee slopes. Inspector Comments: Dense berryvines on landside slope.	38.489962 ° -121.555573 °	38.489962 ° -121.555573 °	81 Y
DWR ID: DWR_RD0765_01_s_2012_81										
31	0.99	0.99		Encroachments	LS	M En	DT : Ditch Inspector Comments: Ditch has been in place for several years.	38.489653 ° -121.555399 °	38.489653 ° -121.555399 °	51 Y
DWR ID: DWR_RD0765_01_s_2013_51										
32	0.99	1.15		Trim / Thin Trees	WS	M Ma	T1 : Trim trees to at least five feet above ground level.	38.489664 ° -121.555370 °	38.487617 ° -121.554200 °	6 Y

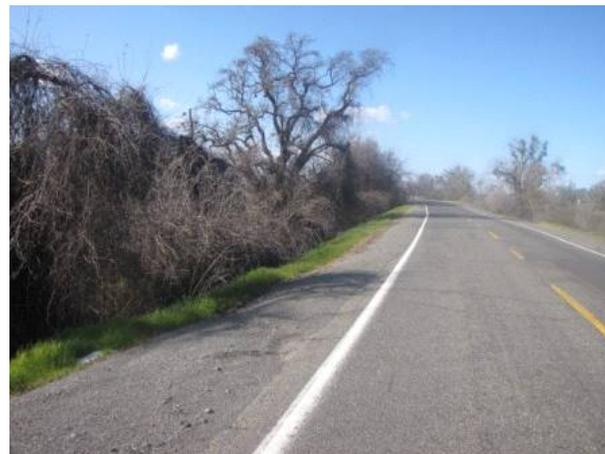
Levee Mile Report Line	29
Start Levee Mile	0.87
End Levee Mile	0.99
Location	Land Side
Category	
Item	Trim / Thin Trees
Looking upstream (north) at dense trees on landside slope and toe.	
richard_s_20130304_714.jpg

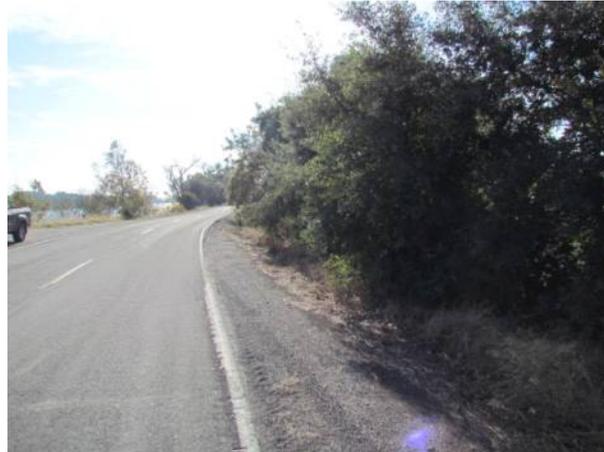
Levee Mile Report Line	29
Start Levee Mile	0.87
End Levee Mile	0.99
Location	Land Side
Category	
Item	Trim / Thin Trees
Looking south at dense trees on landside shoulder and slope. (November 2011)	
richard_s_20130304_715.jpg

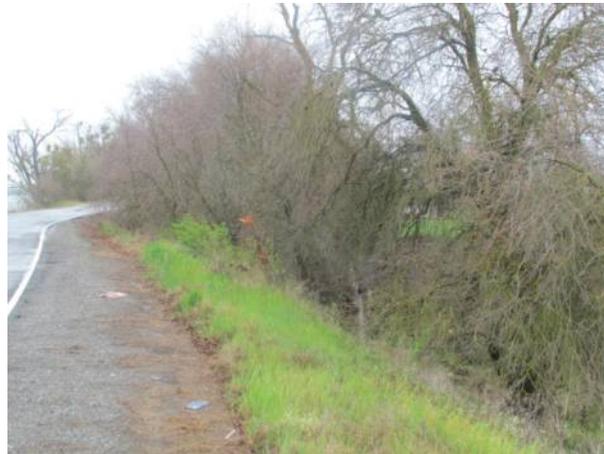
Levee Mile Report Line	29
Start Levee Mile	0.87
End Levee Mile	0.99
Location	Land Side
Category	
Item	Trim / Thin Trees
Looking southwest at dense trees on landside slope and toe spring 2012.	
richard_s_20130304_716.jpg

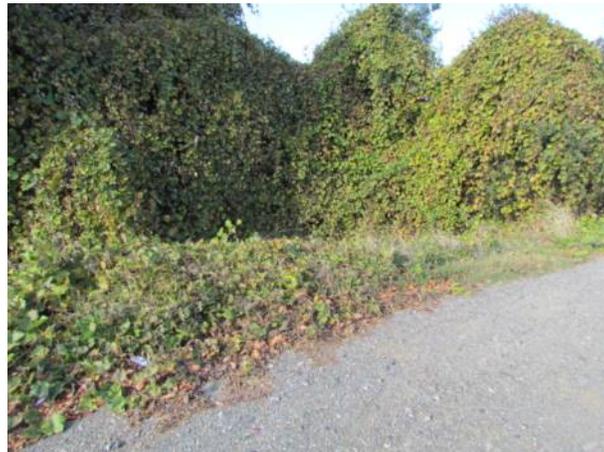
Levee Mile Report Line	30
Start Levee Mile	0.97
End Levee Mile	0.97
Location	Land Side
Category	
Item	Vegetation
Looking west at dense berryvines and wildroses on landside shoulder and slope. (November 2011)	
richard_s_20130304_738.jpg

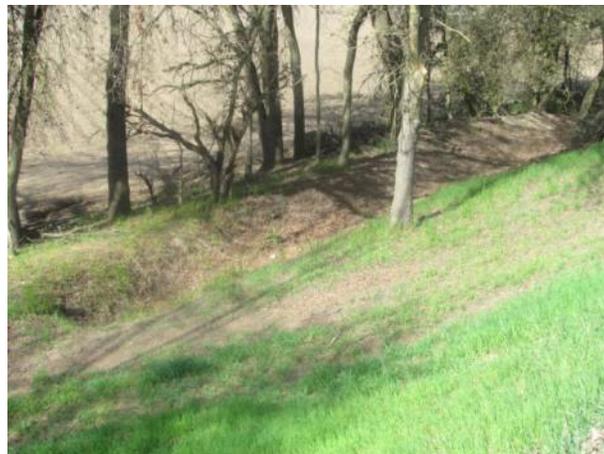
Levee Mile Report Line	31
Start Levee Mile	0.99
End Levee Mile	0.99
Location	Land Side
Category	
Item	Encroachments
Looking west at irrigation ditch at landside toe.	
richard_s_20130307_981.JPG

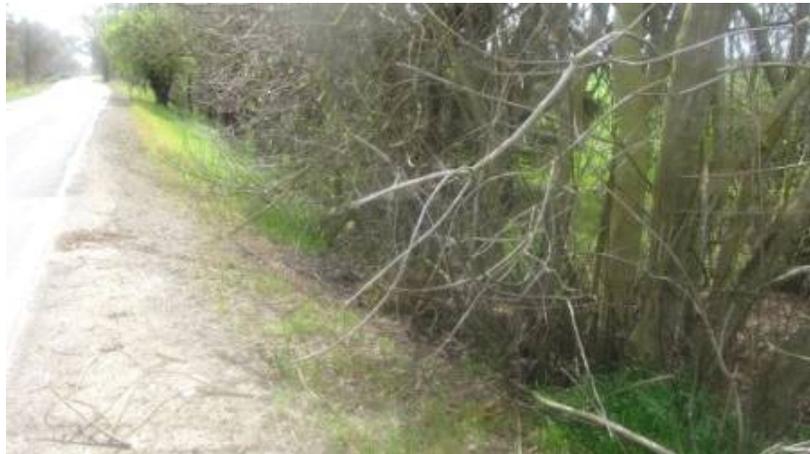
Levee Mile Report Line	35
Start Levee Mile	1.08
End Levee Mile	1.08
Location	Land Side
Category	
Item	Trim / Thin Trees
Looking downstream (south) at trees on landside slope & toe from 2010 fall inspection.	
richard_s_20130304_730.jpg

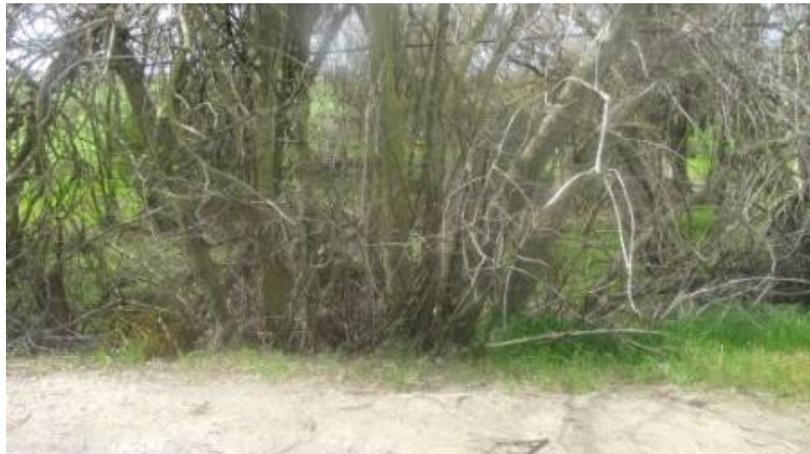
Levee Mile Report Line	35
Start Levee Mile	1.08
End Levee Mile	1.08
Location	Land Side
Category	
Item	Trim / Thin Trees
Looking west at trees on landside slope & toe.	
richard_s_20130304_731.jpg

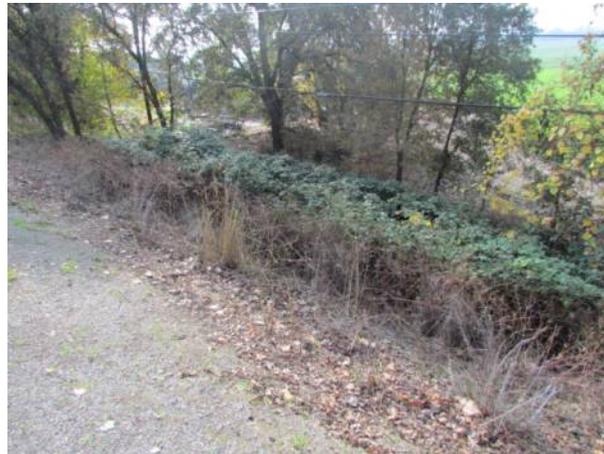
Levee Mile Report Line	37
Start Levee Mile	1.15
End Levee Mile	1.15
Location	Land Side
Category	
Item	Vegetation
Looking southwest at dense vegetation on landside slope and toe.	
richard_s_20130304_737.JPG

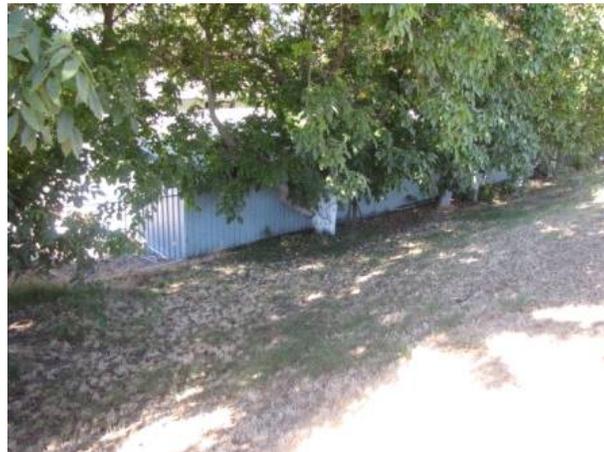
Levee Mile Report Line	39
Start Levee Mile	1.19
End Levee Mile	1.22
Location	Land Side
Category	
Item	Encroachments
Looking northwest at buildings along landside toe.	
richard_s_20130304_735.jpg

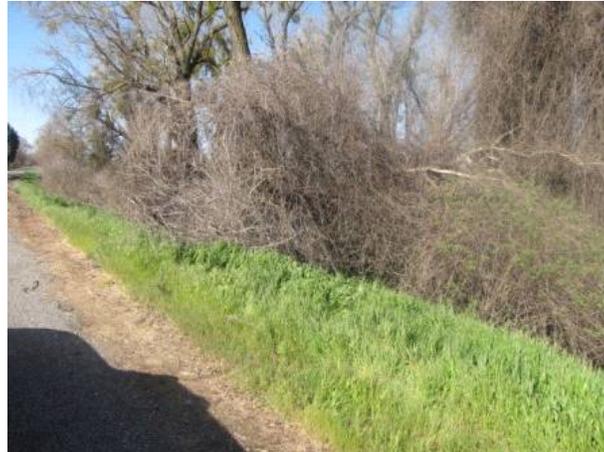
Levee Mile Report Line	42
Start Levee Mile	1.36
End Levee Mile	1.36
Location	Water Side
Category	
Item	Vegetation
Looking upstream (north) at dense vegetation on waterside slope.	
richard_s_20130304_705.jpg

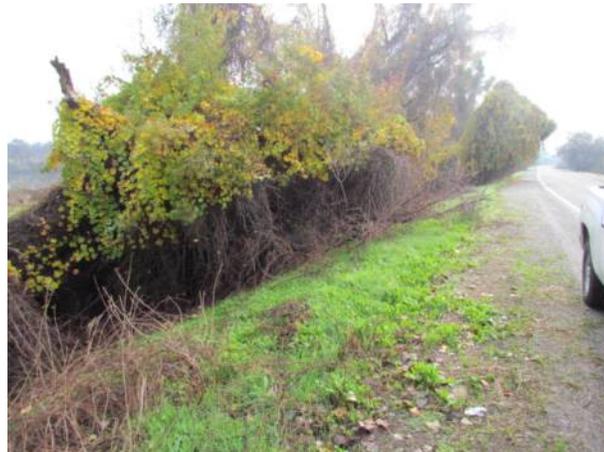
Levee Mile Report Line	42
Start Levee Mile	1.36
End Levee Mile	1.36
Location	Water Side
Category	
Item	Vegetation
Looking southeast at dense vegetation on waterside slope. (Fall Inspection 2012)	
richard_s_20130304_706.JPG

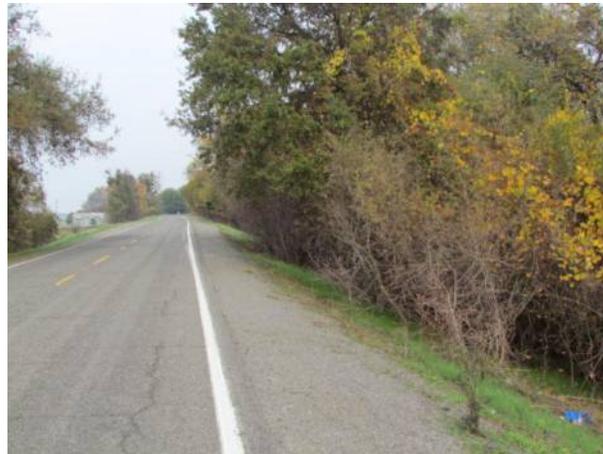
Levee Mile Report Line	44
Start Levee Mile	1.44
End Levee Mile	1.47
Location	Water Side
Category	
Item	Trim / Thin Trees
Looking north at dense vegetation on waterside slope. (Fall Inspection 2012)	
richard_s_20130304_704.JPG

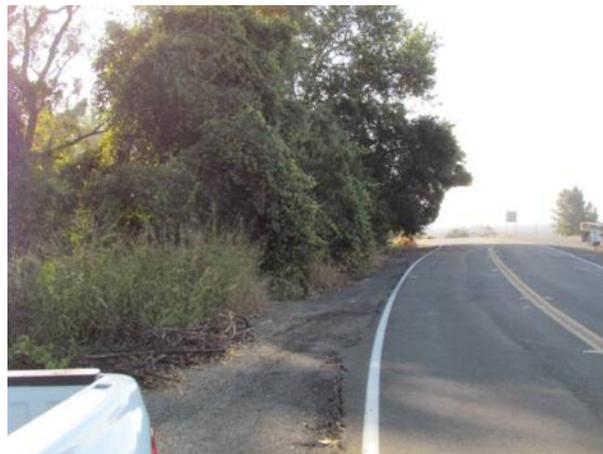
Levee Mile Report Line	47
Start Levee Mile	1.52
End Levee Mile	1.73
Location	Water Side
Category	
Item	Vegetation
Looking south at dense trees and vegetation on waterside slope. (November 2011)	
richard_s_20130304_699.jpg

47	1.52	1.73	Vegetation	WS Ma	U	V2 : Remove the wild growth other than native grasses from the levee slopes.	38.482893 ° -121.551121 °	38.480257 ° -121.549458 °	1 Y
DWR ID: DWR_RD0765_01_s_2012_1									
48	1.54	1.63	Vegetation	LS Ma	U	V2 : Remove the wild growth other than native grasses from the levee slopes.	38.482590 ° -121.551020 °	38.481420 ° -121.550262 °	29 Y
DWR ID: DWR_RD0765_01_s_2012_29									
49	1.54	1.54	Encroachments	WSA/W En	GA	GA : Garbage	38.482610 ° -121.550937 °	38.482610 ° -121.550937 °	2 Y
DWR ID: DWR_RD0765_01_f_2012_2									
50	1.67	1.67	Trim / Thin Trees	WS Ma	M	T1 : Trim trees to at least five feet above ground level.	° -121.549654 °	38.480892 ° -121.549654 °	53 Y
DWR ID: DWR_RD0765_01_s_2013_53									
51	1.69	1.69	Encroachments	WSA/W En	GA	GA : Garbage Inspector Comments: District removed trash.	38.480770 ° -121.549514 °	38.480895 ° -121.549556 °	30 Y
DWR ID: DWR_RD0765_01_s_2012_30

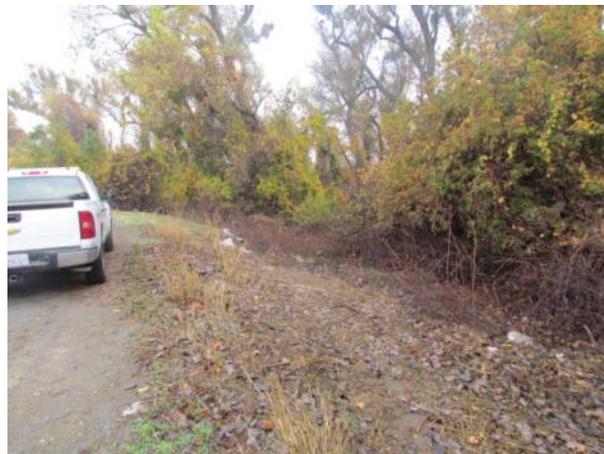
Levee Mile Report Line	47
Start Levee Mile	1.52
End Levee Mile	1.73
Location	Water Side
Category	
Item	Vegetation
Looking northeast at dense vegetation on waterside slope.	
richard_s_20130304_701.JPG

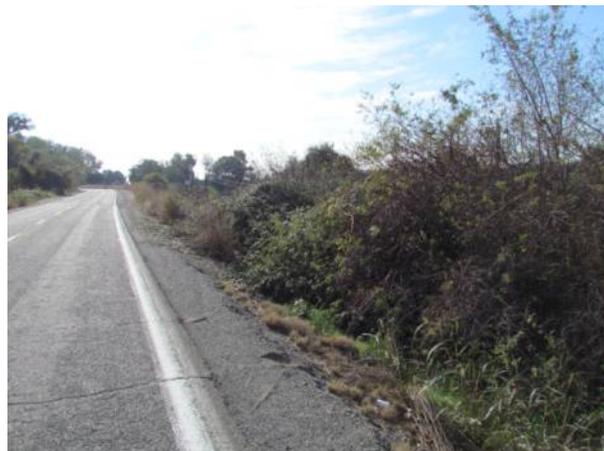
Levee Mile Report Line	48
Start Levee Mile	1.54
End Levee Mile	1.63
Location	Land Side
Category	
Item	Vegetation
Looking south at dense vegetation on landside shoulder and slope. (November 2011)	
richard_s_20130304_720.jpg

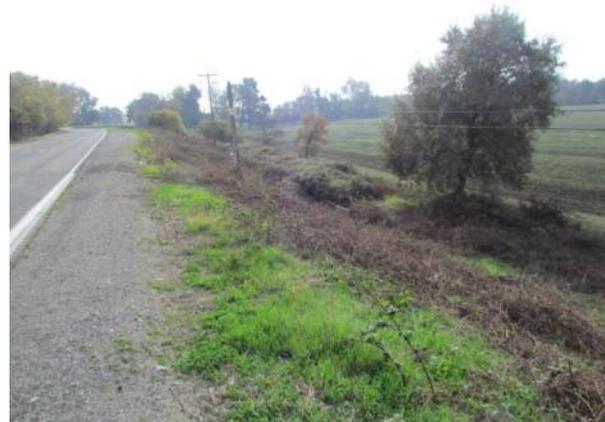
Levee Mile Report Line	48
Start Levee Mile	1.54
End Levee Mile	1.63
Location	Land Side
Category	
Item	Vegetation
Looking southwest at vegetation on landside slope and toe. (Fall Inspection 2012)	
richard_s_20130304_722.JPG

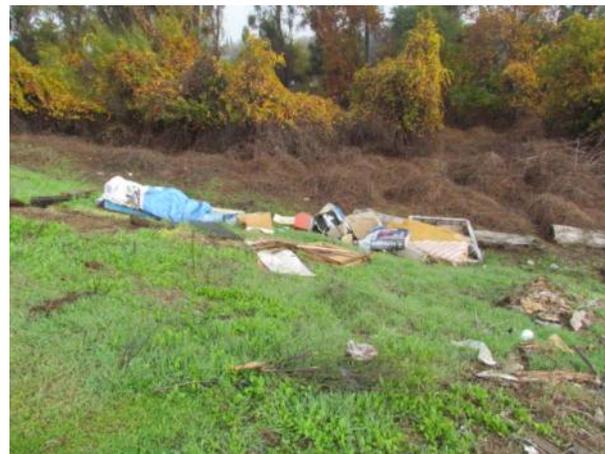
Levee Mile Report Line	49
Start Levee Mile	1.54
End Levee Mile	1.54
Location	Water Side
Category	
Item	Encroachments
Looking northeast at garbage on waterside slope.	
richard_s_20130304_702.JPG

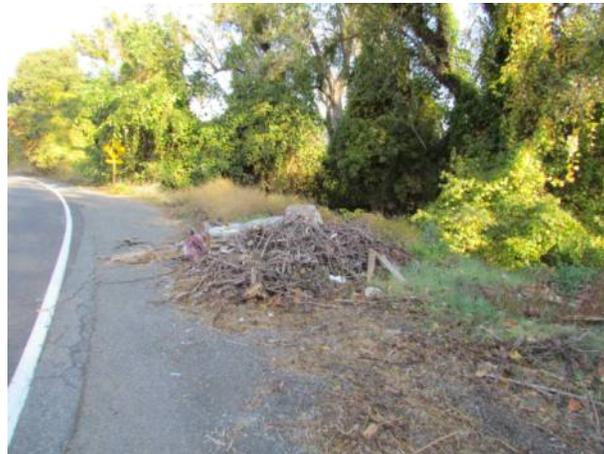
Levee Mile Report Line	51
Start Levee Mile	1.69
End Levee Mile	1.69
Location	Water Side
Category	
Item	Encroachments
Looking north at garbage and pruning pile on waterside shoulder. (November 2011)	
richard_s_20130304_724.jpg

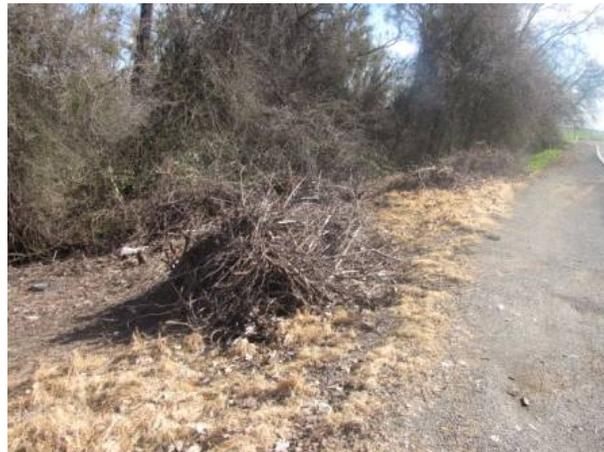
52	1.69	1.70	Encroachments	WSA/W Ma	PR	PR : Prunings Inspector Comments: Landowner burned pruning pile.	38.480763 ° -121.549581 °	38.480632 ° -121.549543 °	13 Y
DWR ID: DWR_RD0765_01_s_2012_13									
53	1.71	1.72	Trim / Thin Trees	WS Ma	U	T1 : Trim trees to at least five feet above ground level.	38.480519 ° -121.549513 °	38.480164 ° -121.549445 °	52 Y
DWR ID: DWR_RD0765_01_s_2013_52

Levee Mile Report Line	52
Start Levee Mile	1.69
End Levee Mile	1.70
Location	Water Side
Category	
Item	Encroachments
Looking southeast at pruning piles on waterside shoulder & slope.	
richard_s_20130304_711.jpg
